Characterization of Historic Mortar:
Tucker Free Library
31 Western Avenue
Henniker, NH 03242

Prepared by:
Anthony R.C. Hita, AIC-PA
Architectural Conservator
LimeWorks.us

November 22, 2021

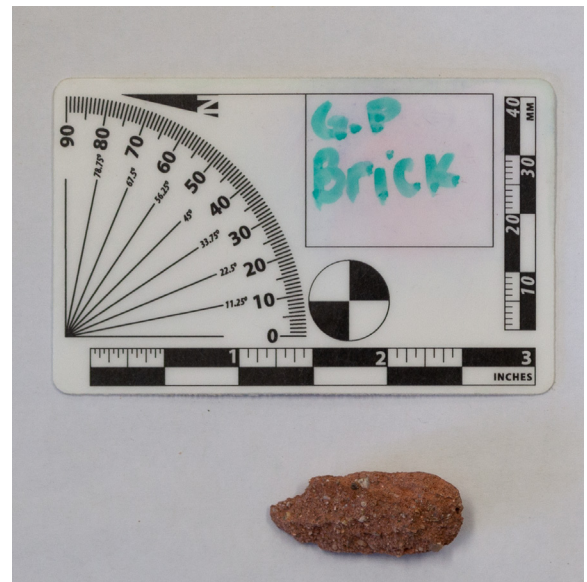
Photograph of the weathered face of the bulk sample before digestion (fluorescent light, color corrected).

- **Layering:** No layering was observed.
- **Color:** The weathered face of the bulk sample corresponded to 10R 5/6 red.
- **Hardness:** The sample was cohesive and hard with a Mohs rating of 9, requiring excessive force to pulverize with a mortar and pestle. This is consistent with a cement-containing mortar.

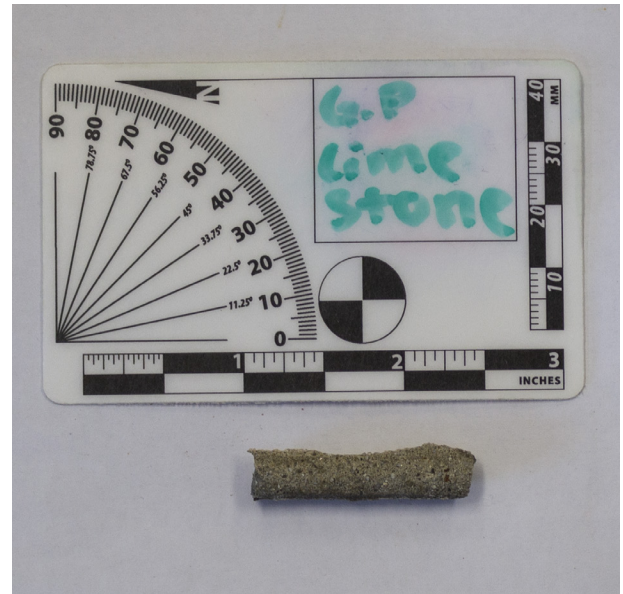
Photograph of the weathered face of the bulk sample before digestion (fluorescent light, color corrected).

- **Layering:** Samples showed evidence of at least two pointing campaigns, with a denser harder mortar near the surface and a softer lighter mortar behind. The layers could not be separated easily, leading to problematic testing conditions.

- **Color:** The weathered face of the bulk sample corresponded to 2.5Y 6/2 light brownish gray.
- **Hardness:** The surface mortar was hard and dense with a Mohs rating of 8.5, while the back mortar was softer with a Mohs of 5. The overall sample required moderate force to crush with a mortar and pestle. Both samples are consistent with cement-lime mixes of various proportions and vintages.

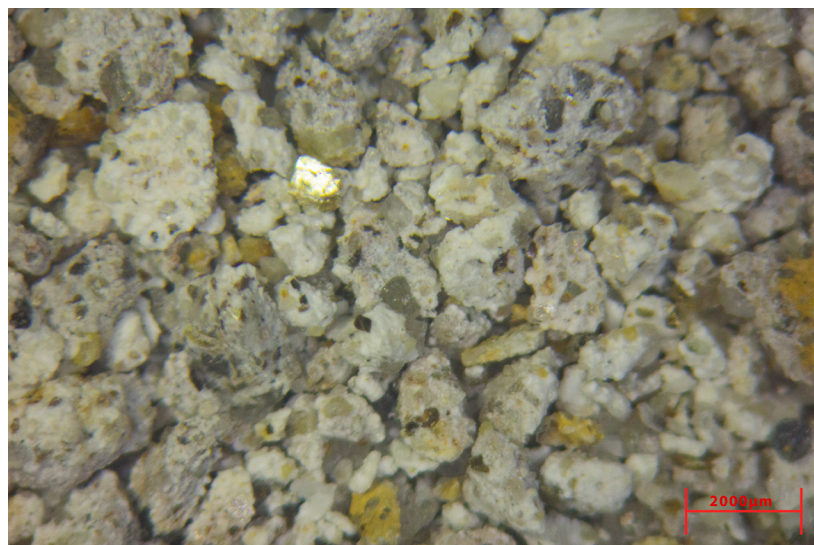
Photomicrograph of the extracted aggregate before sieving, note the abundant undigested binder clumps (incident daylight-balanced light, 10x magnification).

The individual color of grains could not be fully determined due to undigested binder skewing sieves lighter and grayer in virtually every sieve. However, with the binder included, average particles tended towards light gray to white with an overall average of 10YR 8/1 *white*.

In addition, small piece of shell were observed in most sieves. These shell portions probably came from the older likely lime-based mortar that was clinging to the rear of the harder likely Portland-based mortar, or may be natural portions of the aggregate. Because of the undigested binder and multiple pointing phases, this mortar is a good candidate for further testing according to ASTM C1324.

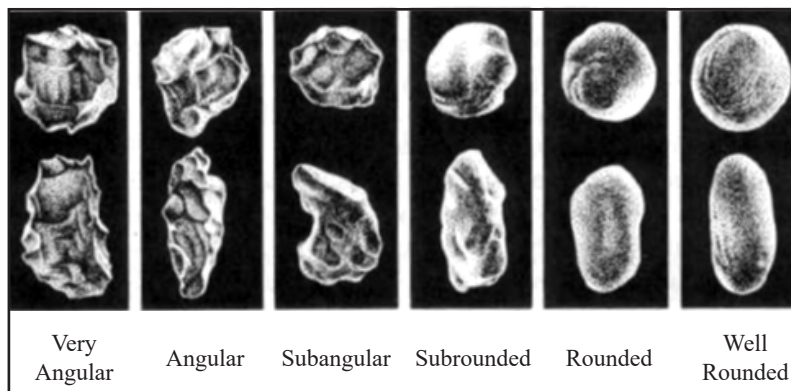
- Roundness:** Roundness is an observation of the sharpness of the edges and corners of a particle. A particle that is significantly worn by abrasion to the point that it appears smooth is considered *well-rounded*, while a particle that appears cleaved with very sharp edges and little abrasion is considered *very angular*.

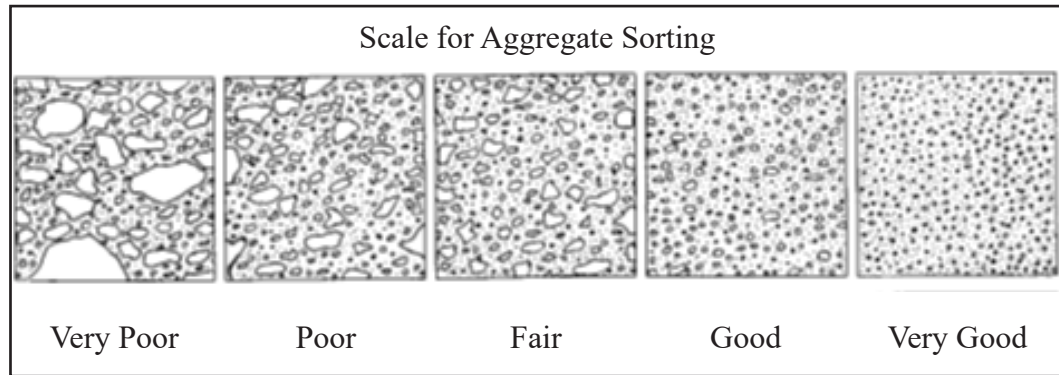
- Sorting:** Sorting is a description of the degree of distribution of particles of varying size and shape within an individual sample. Samples that are *well-sorted* have nearly homogeneous size and shape distribution, while those that are *poorly sorted* have heterogeneous size and shape distribution.

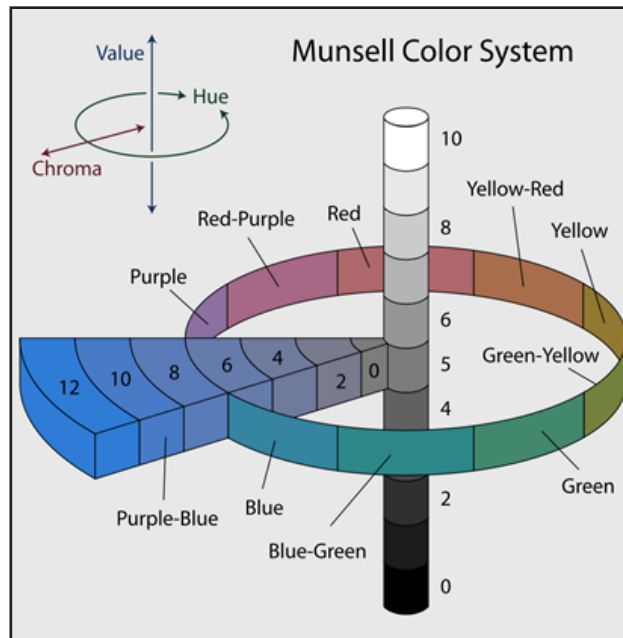
- Color:** Because color is subjective, the Munsell Color System attempts to classify the visual experience of color into perceived attributes of hue, lightness, and chroma. These values only apply to opaque samples that are viewed by individuals with healthy color vision in daylight conditions. This method provides a simple, more cost effective alternative to analytical procedures such as spectrophotometry. Munsell notations are given a number-letter-number combination in the form number-letter-slash-number representing Munsell hue (H), Munsell value (V), and Munsell chroma (C). A Munsell color guide also assigns each value an official name. Color classification using the Munsell Color System is performed in accordance to the procedures outlined in ASTM D1535.
